## ***KM/CS-3050/4050/5050 Firmware Release Notes***

<b>Subject:</b>	<b>Firmware Update</b>
<b>Model</b>	<b>KM/C-3050/4050/5050</b>
<b>Updated Machines Serial Number:</b>	<b>N/A</b>

**The Combined Firmware is updated to Version 2.20C 09/08**

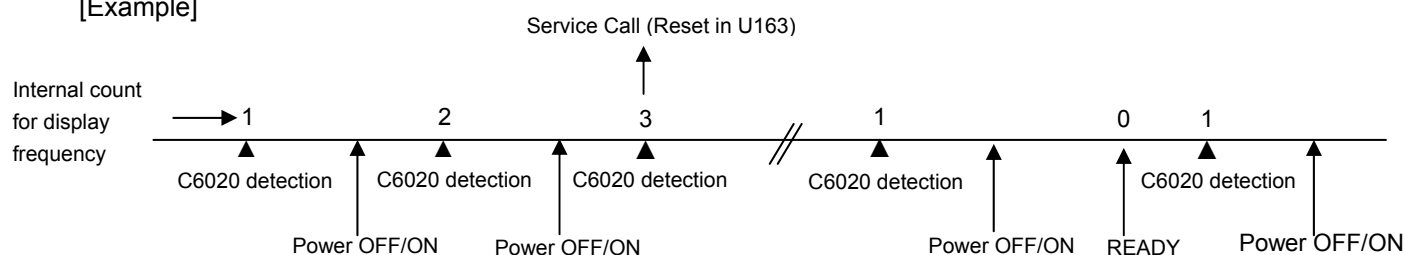
### **Change on displaying and resetting of C6020 (Abnormally high fuser unit Thermistor temperature)**

The displaying and resetting of C6020 (Abnormally high fuser unit thermistor temperature) has been changed as illustrated below.

- If a C6020 is detected, it will be displayed as a system error and can be reset by turning the power OFF and then ON. (Up to two times)
- The third time when a C6020 is detected, it will be displayed as a service call. (Please reset it in maintenance mode U163.)

The number of occurrence will be reset (to "0") when the main unit enters ready mode.

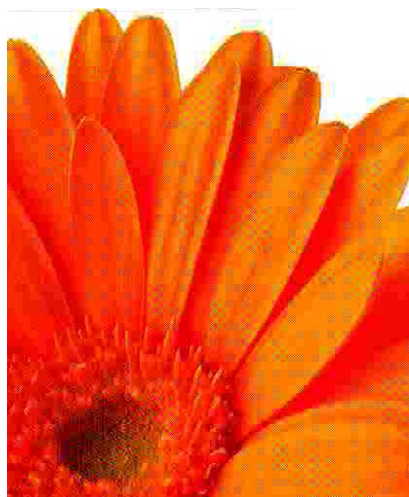
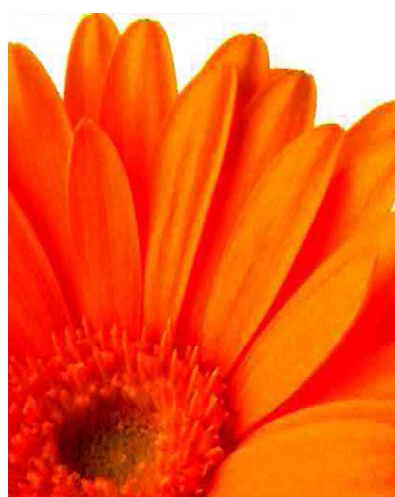
### ■ Support to improve the scanner image quality

JPEG/PDF/TIFF image quality setting (5 steps)

- Change to the image process filter
- U470 [Set JPEG Compression rate] is added to make the compression ratio for each step changeable.

Before change

After change (Noise or moiré are reduced)
